Manhole Inspection Summary

Manhole # S65Q__003MH

Location Address: **1442 Cardiff Ave.**

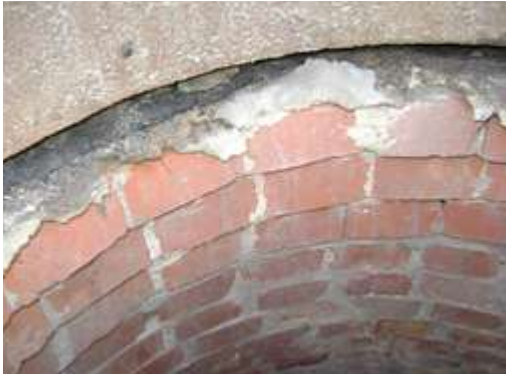
Defect 1

missing mortar under frame

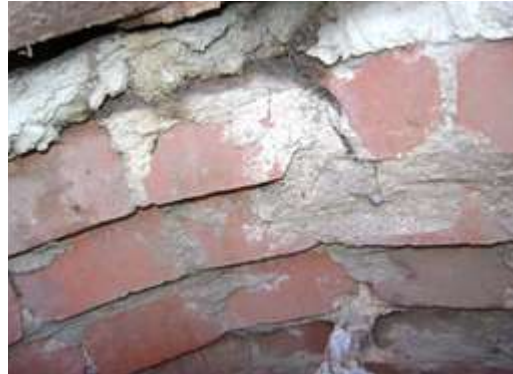
Defect 2

gap under frame

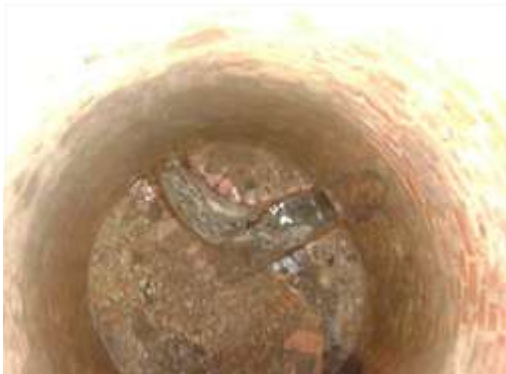
Defect 3

Condition: ☐ Sound ☐ Cracked ☐ Root Intrusion ☐ Deteriorated ☐ Leaks ☒ Debris

Debris on bench

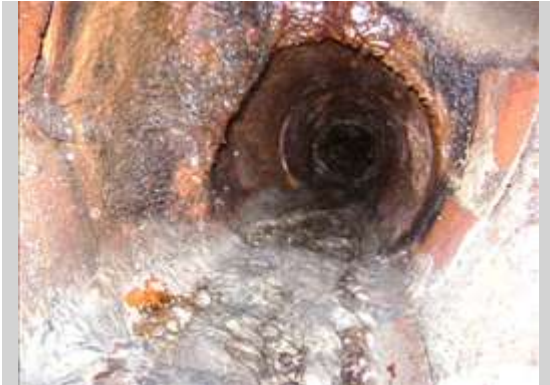
12 O'Clock Outflow

8 in. Circular Gravity Sewer
Pipe Out @ 12 O'Clock

Pipe Height: **8.4** (in.) Rod and Bar (Angled)
Pipe Material: **Clay** ☐ Pipe Lined
Invert Depth: **9.17** (ft.) Flow Characteristics: **Slow**
Deposits: ☒ None ☐ Mud ☐ Sludge ☐ Debris ☐ Grease
Silt Depth: (in.) Deposits Extent:
Infiltration: **None** Pipe Seal Cond: **Sound**

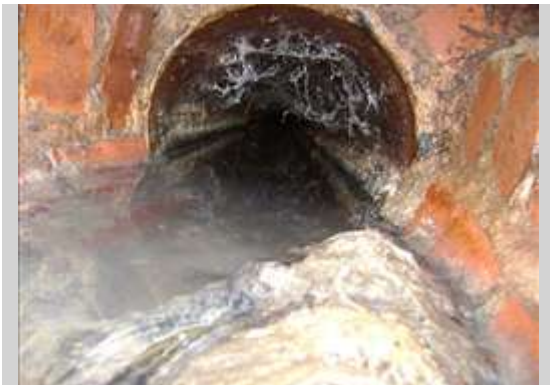
3 O'Clock Inflow

8 in. Circular Gravity Sewer
Pipe In @ 3 O'Clock

Pipe Height: **8.4** (in.) Rod and Bar (Angled)
Pipe Material: **Clay** ☐ Pipe Lined
Invert Depth: **9.08** (ft.) Flow Characteristics: **Slow**
Deposits: ☒ None ☐ Mud ☐ Sludge ☐ Debris ☐ Grease
Silt Depth: (in.) Deposits Extent:
Infiltration: **None** Pipe Seal Cond: **Sound**
